Assessment of the sprayer inspection results in Catalonia

Francesc Solanelles, Ferran Camp, Alba Fillat, Felip Gracia

Centre de Mecanització Agrària. DARP

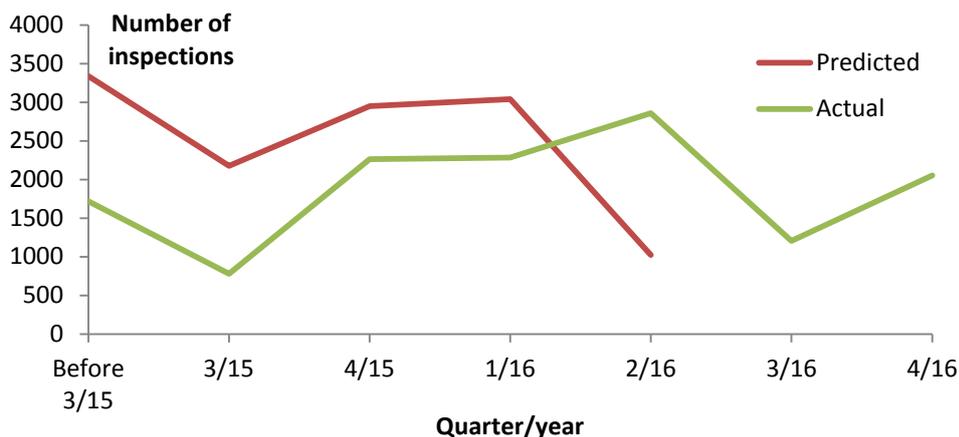
Figure 1. Quarterly evolution of the inspections predicted in the programme and the actual inspections

Figure 1 shows the comparison between the number of pesticide application equipment, which was planned to be inspected every term, and the number of inspections that were finally made. The amount of inspections carried out during the 4 quarters of the programme was lower than expected. However, it is noticed that at the beginning –third quarter of 2015- the number of inspections clearly increases. This must be triggered by the writing communications that were sent to the owners of the sprayers. Moreover, it can also be noticed that after the end of the programme, in the second quarter of 2016, inspections were also being carried out at a brisk pace. The inspections made before the beginning of the programme are related with a previous communication to sprayer owners in 2014.

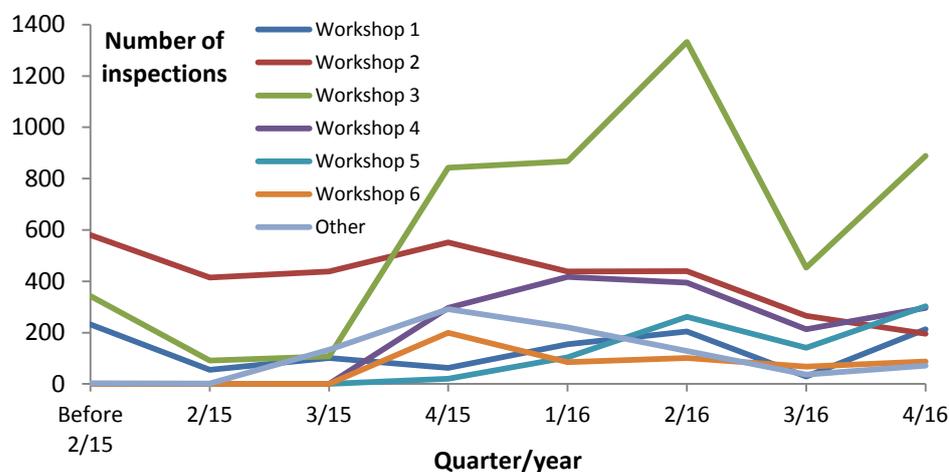
Figure 2. Quarterly evolution of the inspections carried out by the different workshops

The number of inspections carried out by the different workshops is depicted in figure 2, showing separately six of them, those who carried out most of the inspections. The trend in this figure is similar to that of the previous one, because the number of inspections of some of the workshops increases from the third quarter of 2015 on, when the inspection programme was started. The important differences in the number of inspections by some workshops in the same period of time, can be explained by the number of inspection vehicles used simultaneously by each workshop.

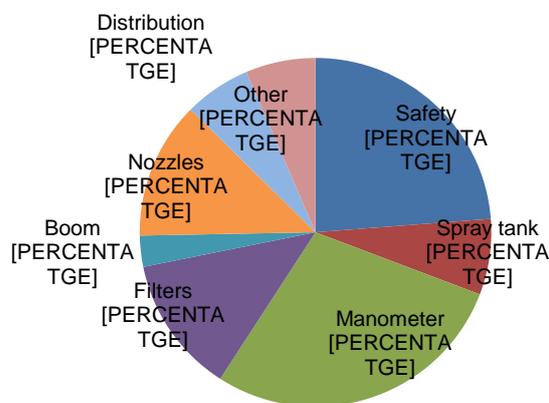
Figure 3. Percentage of defects found during the inspection of all types of pesticide application equipment

Figure 3 shows the sprayer defect occurrence, which is reported in the unfavourable inspections. The most frequent malfunction is related with the measurements systems of the equipment, mainly faulty pressure gauges, which are not compliant with the requirements of the inspection standard. For instance, the scale of the pressure indicator can be inadequate –more than 0.2 bar in horizontal boom sprayers and more than 1.0 bar in sprayers for bush and tree crops. It is also frequently reported that the accuracy of the machine pressure gauge, which is measured during the inspection, is worse than required. Whatever the malfunction of the manometer, it has to be replaced by a new one.

The second group of defects spotted during the inspection is related with the protection of the operator. They are mainly related with the guards of the moving parts of the machine. These elements can be deteriorated or, in some cases, they are missing. The guard of the power take-off drive shaft, between the tractor and the machines, is usually deteriorated with the use. In many cases, however, it had been replaced before the inspection. Therefore, the faults that are more likely to be reported during the inspection are related with the guards of other power transmission parts. For instance, the power input connection before the sprayer pump and the fan power transmission. Other faulty safety devices are also reported in the sprayer fan itself, if guards to prevent the access are non-compliant.

Another important group of defects has to do with the filters. According with the inspection standard requirements, there shall be at least one filter on the discharge side of the pump –pressure section of the sprayer manifold, between the pump and the nozzles- and one filter on the suction side, if the sprayer is equipped with positive displacement pumps. Many small boom sprayers used for band spray applications in tree and bush crops, or equipped with guns and lances, don't have filters in the required position. It is also thought that, sometimes, the missing filters were mounted on the sprayers before the inspection and, therefore, the reported defects during the inspection are not an accurate indicator of the actual condition of the sprayers in use.

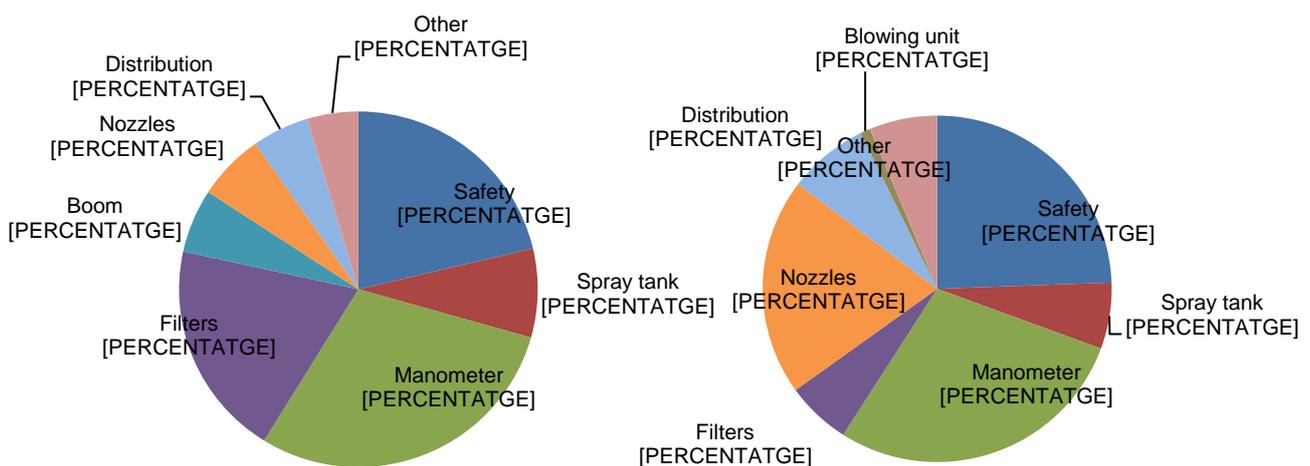
Figure 4. Percentage of defects found in the inspection of horizontal boom sprayers (left) and sprayers for bush and tree crops

For a more detailed assessment of the defects and malfunctions reported during the inspections, figure 4 shows the differences found between horizontal boom and air-assisted sprayers. In relation with the filters, the percentage of defects is higher in boom sprayers. This may be caused, as it is said before, by the design of the small sprayers used for herbicide applications in tree and bush crops. On the other hand, air-assisted sprayer inspections report a higher number of nozzle defects than boom sprayers. For air-assisted sprayers, the malfunction of the blowing unit is also indicated, although the percentage is very low. This can be explained by the fact that defects in the blowing unit are mainly related with safety devices, which are already reported in the safety section.
